CRAFTSMAN'S CRIBSHEET

NUMBER
52

Central Bursts, Chevroning in Cold Drawn and Extruded Steels

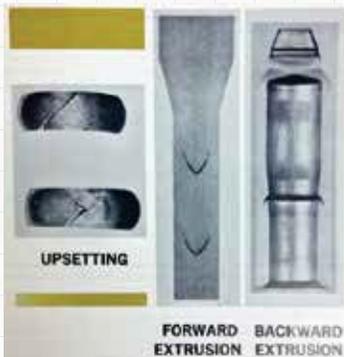
The compressive stresses of cold working can result in failures by shear along planes 45 degrees to the applied stress. These are known as shear failures. The presence of shear failures in an otherwise metallurgically normal material indicates excessive mechanical deformation. While often the result of tooling issues, conditions which lower material ductility include chemistry, macrostructure, nonmetallics, microstructure and aging. Hydrogen embrittlement has also been implicated in investigations of premature shear failure.

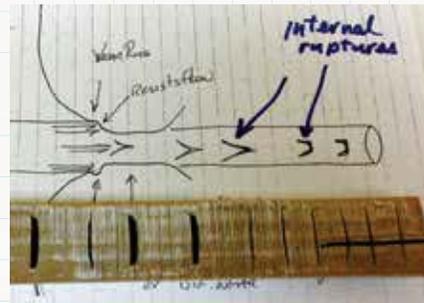
hardening coefficient of the grade involved. A bar which exhibited central bursting was saw cut lengthwise to show the internal ruptures.

The role of tooling at the cold drawing mill is usually considered to be the root cause, as replacement of dies typically eliminates the central bursting. Increased stresses as the result of a "wear ring" in the die are generally found to be the cause of the bursting rather than smooth flow of the material. Other factors involved include die angle (half angle), reduction in area, friction in process and strain

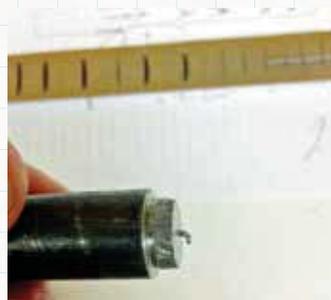
In very rare cases, while machining parts from a bar which exhibits internal bursts or chevrons, the part will separate from the bar in the process because of the prior existing rupture. The photo below shows such a part. Note the fracture surface on the sides of the stepped down diameter on the part end shown in the photo below.

You might see these kinds of failures more often found in parts that are cold headed or cold extruded. Central bursts or internal chevrons are very rare in the marketplace these days, as a result of improved tooling, drawing lubricants, die design and maintenance at the mills. However, if you find parts breaking off on the machine prior to being cut, you just might be encountering central bursts in the steel.
